# Manhole Inspection Summary

Manhole # S69M\_\_024MH

**Location** Address: **6608 O'Donnell St.**

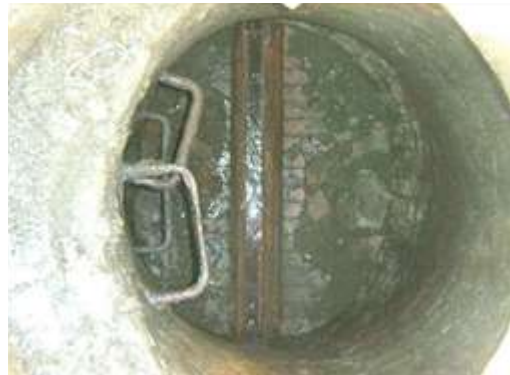
Top View

**Frame** Offset: **5** (in.) Condition: ☐ Sound ☒ **Cracked** ☒ **Leaks**

Condition: ☐ Sound ☐ Cracked ☐ Root Intrusion ☒ **Loose Brick** ☐ Deteriorated

Infiltration: ☐ None ☒ **Joint** ☐ Cracks ☐ Mortar ☐ Roots ☐ Wall
